Northern Pipeline Interconnector 2 (NPI2)

Annual Compliance
Report 2023 - 2024

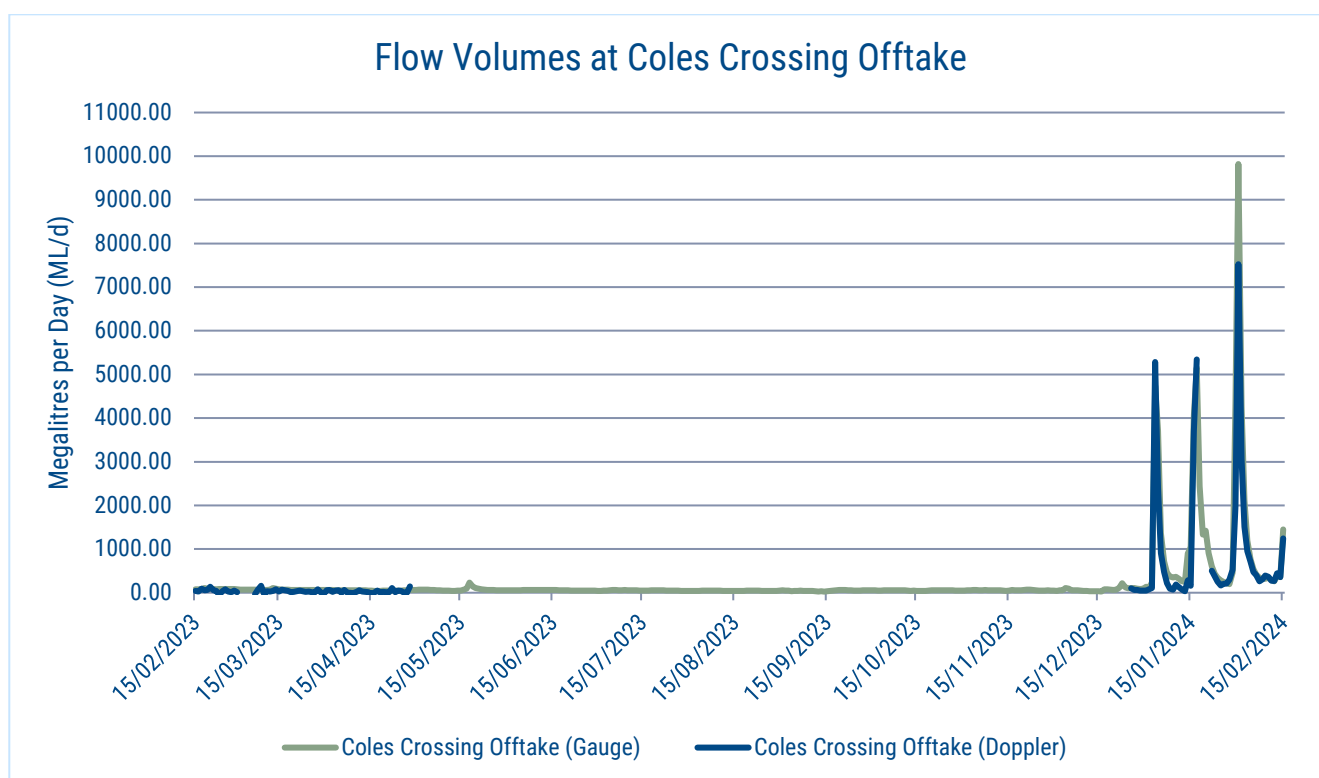
Figure 2. Average Flow Volumes at Coles Crossing Offtake

As previously noted, although the OEMP specifies the use of an Acoustic Doppler for flow monitoring, the industry-standard method is deemed more reliable. This method enables the assessment of operations to achieve the monitoring program’s intent and, consequently, the approval requirements. Daily flow volumes can be provided to DCCEEW upon request.

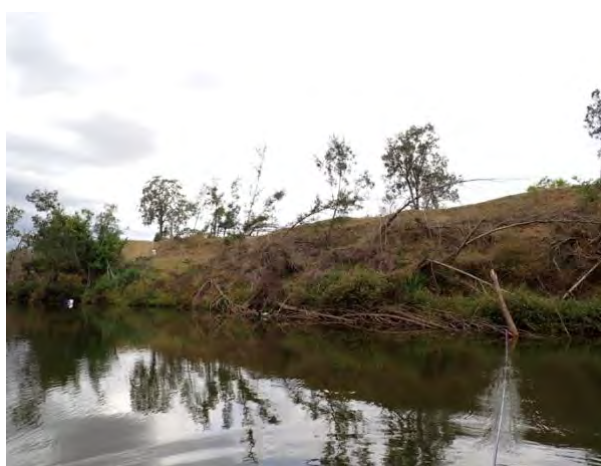
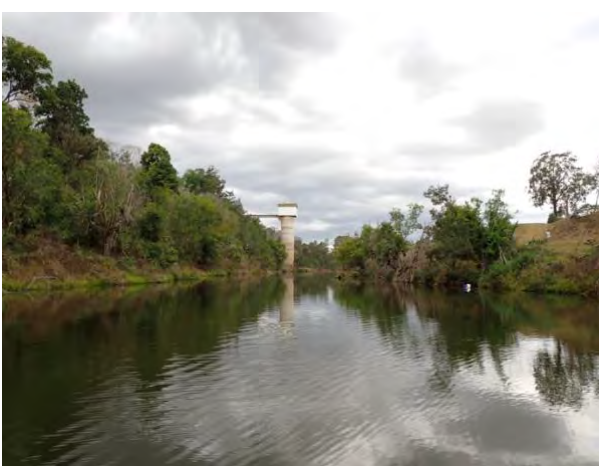
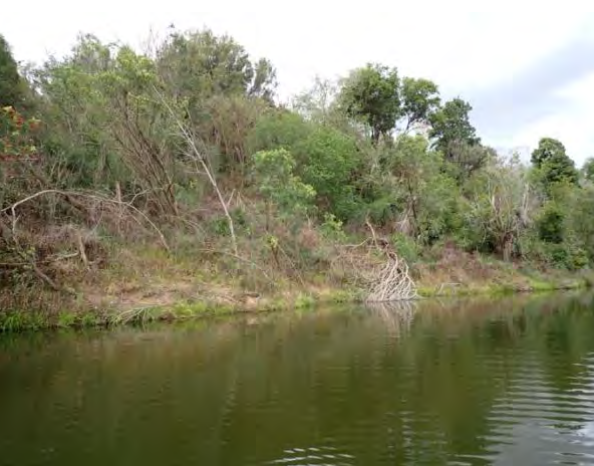
Site MR1

Right bank at mid-site		Upstream at mid-site		Left bank at mid-site	
Water Quality		Flow Conditions			
Temperature (°C)	21.7	Flow habitats present	Connected in-channel pool		
Conductivity (µS/cm)	359.61	Water level	Moderate (at watermark)		
Turbidity (NTU)	9.12	Recent high flow	Yes		
Dissolved oxygen (mg/L)	9.13	Flow	Upstream	Mid-site	Downstream
Dissolved oxygen (% sat)	113.57	Depth (m)	1.6	2.6	2.3
pH	7.53	Width (m)	31.0	39.5	40.0
		Velocity (m/s)	0.048	0.025	0.031

Land Use			
Left bank:	Pump station	Right bank:	Grazing
Overall disturbance:	Moderate		
Bank Assessment			
Left Bank		Right Bank	
Bank material:	Gravel, sand, clay	Bank material:	Sand, clay
Bank height:	5 m	Bank height:	5 m
Bank slope:	Steep	Bank slope:	Steep
Bank shape:	Concave	Bank shape:	Concave
Vegetation cover:	Moderate	Vegetation cover:	Extensive
Vegetation type:	Grass, shrubs, trees	Vegetation type:	Grass, shrubs, trees
Shading of river:	5%	Shading of river:	5%
Trailing bank vegetation:	10%	Trailing bank vegetation:	5%
Erosion Assessment			
Left Bank		Right Bank	
Erosion:	Moderate	Erosion:	Moderate
Stability:	Moderate	Stability:	Moderate
Disturbances:	Weeds, cleared vegetation	Disturbances:	Weeds, cleared vegetation, access tracks
Bed Assessment			
Substrate material:	Pebble, gravel, sand and silt/clay		
Bed stability rating:	Bed stable	Sediment deposits:	Silt and sand

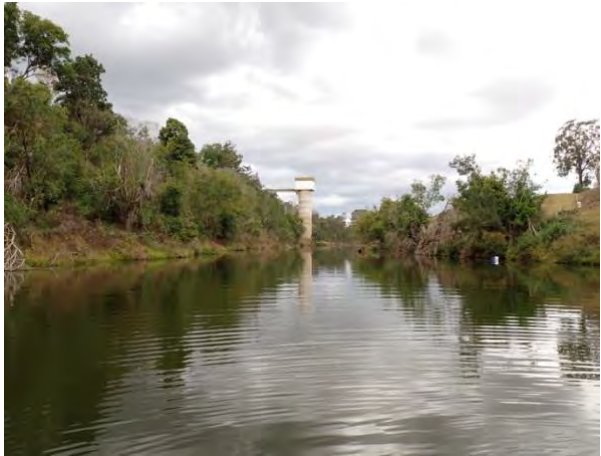
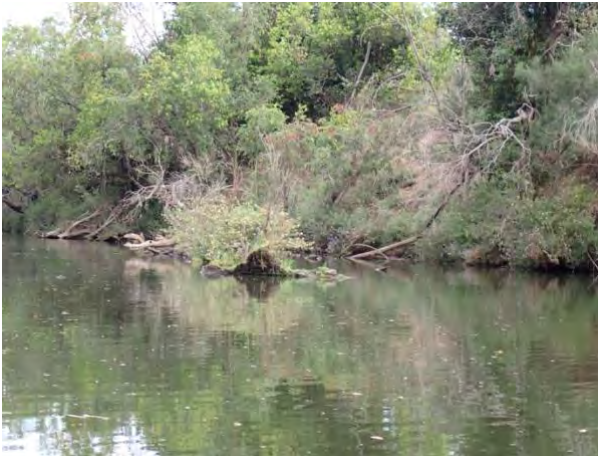
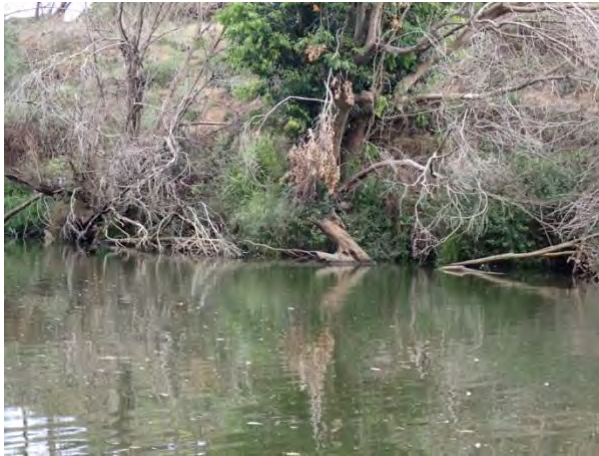
Table B.2 Site MR1 – habitat assessment for MNES species

Connected pool with slow flow		Bar and logs suitable for basking	
Submerged logs suitable for refuge			
Habitat	Present / Absent	Habitat	Present / Absent
Isolated pools	Absent	Individual log (diameter >250mm)	Present
Connected pools	Present	Individual branch (diameter <300mm)	Present
Riffle	Absent	Branch pile <50% dense (diameter <300mm)	Present
Run	Absent	Branch pile >50% dense (diameter <300mm)	Present
Aquatic vegetation	Present	Log jam <50% dense (diameter >300mm)	Present
Turtle basking spots	Present	Log jam >50% dense (diameter >300mm)	Present
Turtle nesting habitat	Absent	Terrestrial leaves and twigs	Present – sparse
Submerged boulders / rock crevices	Present		
Overall suitability	Suitable

MNES Species Habitat	
Comments:	Patches of potentially suitable habitat for Mary River cod, White-Throated Snapping turtles, Mary River turtles and Australian Lungfish were scattered throughout the site. Pools were deep to 3 m. Some banks were moderately shaded and contained large woody debris. Turtle basking spots and submerged boulders/rock crevices were present in limited numbers, while turtle nesting habitat were absent at MR1. Aquatic vegetation was present, <i>Azolla</i> sp. and water hyacinth sp. found. Turtles were spotted at MR1 (unable to identify species) as well as Australian Lungfish between MR1 and MR2.

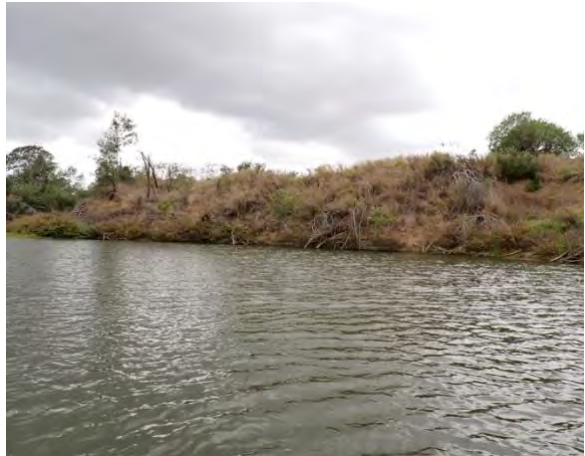
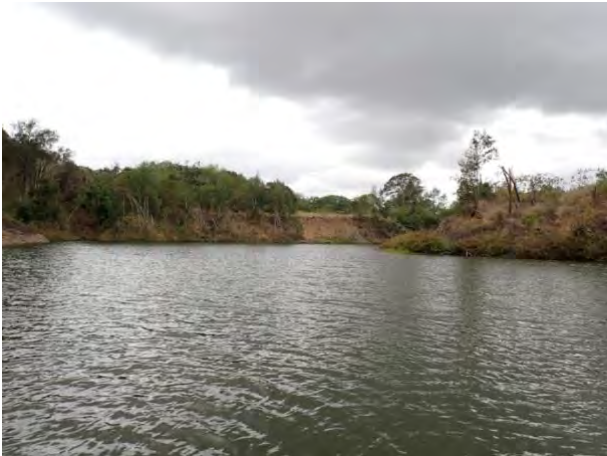
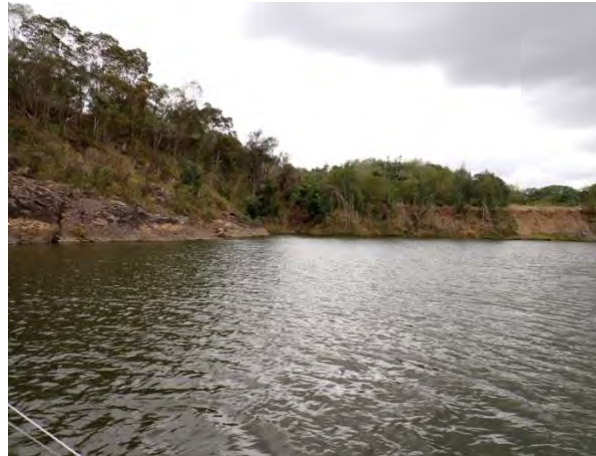
Site MR2

Right bank at mid-site		Upstream at mid-site		Left bank at mid-site	
Water Quality		Flow Conditions			
Temperature (°C)	24.19	Flow habitats present	Connected in-channel pool		
Conductivity (µS/cm)	404.61	Water level	Moderate (at watermark)		
Turbidity (NTU)	8.4	Recent high flow	Yes		
Dissolved oxygen (mg/L)	7.3	Flow	Upstream	Mid-site	Downstream
Dissolved oxygen (% sat)	86.67	Depth (m)	2.9	4.9	3.5
pH	6.96	Width (m)	49.0	68.0	61.0
		Velocity (m/s)	0.02	0.09	0.03

Land Use			
Left bank:	Grazing	Right bank:	Grazing
Overall disturbance:	High		
Bank Assessment			
Left Bank		Right Bank	
Bank material:	Boulder, pebble, gravel, clay	Bank material:	Cobble, sand, silt/clay
Bank height:	8 m	Bank height:	10 m
Bank slope:	Steep	Bank slope:	Moderate
Bank shape:	Convex	Bank shape:	Convex
Vegetation cover:	Moderate	Vegetation cover:	Moderate
Vegetation type:	Grass, shrubs, trees	Vegetation type:	Grass, shrubs, trees
Shading of river:	5%	Shading of river:	5%
Trailing bank vegetation:	5%	Trailing bank vegetation:	10%
Erosion Assessment			
Left Bank		Right Bank	
Erosion:	Moderate	Erosion:	Moderate
Stability:	Moderate	Stability:	High
Disturbances:	Erosion	Disturbances:	Erosion, weeds, cleared vegetation, cattle
Bed Assessment			
Substrate material:	Bedrock, boulder, cobble, pebble, gravel, sand, silt/clay		
Bed stability rating:	Moderate erosion	Sediment deposits:	Sand, silt

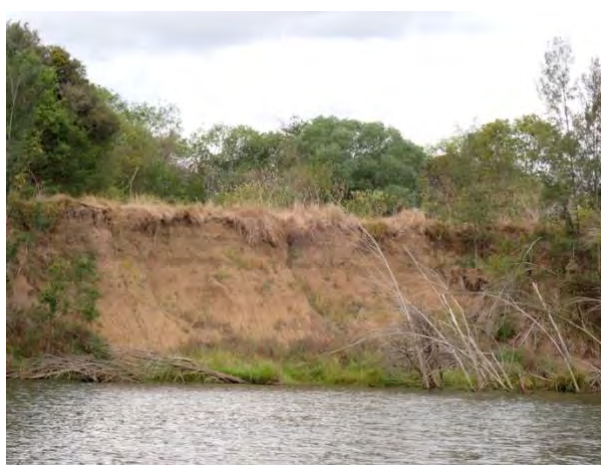
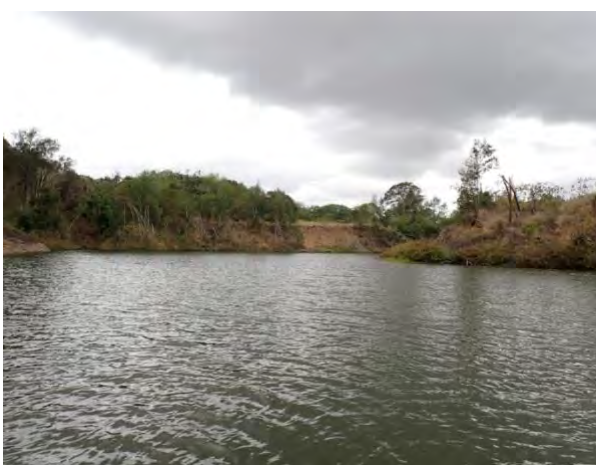
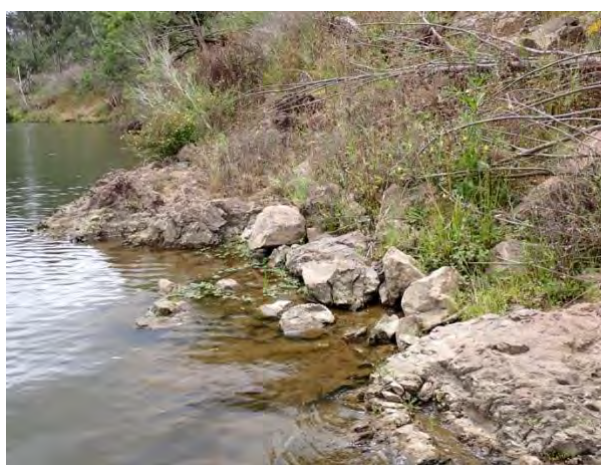
Table B.4 MR2 – habitat assessment for MNES species.

Eroded sandy/pebble banks		Connected pool with slow flow

Rocky banks suitable for basking			
Habitat	Present / Absent	Habitat	Present / Absent
Isolated pools	Absent	Individual log (diameter >250mm)	Present
Connected pools	Present	Individual branch (diameter <300mm)	Absent
Riffle	Absent	Branch pile <50% dense (diameter <300mm)	Absent
Run	Absent	Branch pile >50% dense (diameter <300mm)	Present
Aquatic vegetation	Absent	Log jam <50% dense (diameter >300mm)	Absent
Turtle basking spots	Present	Log jam >50% dense (diameter >300mm)	Absent
Turtle nesting habitat	Absent	Terrestrial leaves and twigs	Present – sparse
Submerged boulders / rock crevices	Present		
Overall suitability	Suitable

MNES Species Habitat.	
Comments:	Patches of potentially suitable habitat for Mary River turtles and White-Throated Snapping turtles were observed. Some basking locations were largely present however turtle nesting habitats were eroded, reducing habitat suitability. Deep pools (>5 m) throughout the site provide good habitat for both Australian Lungfish and Mary River cod. Submerged large woody debris provide habitat and shelter. Aquatic plants were not observed at site MR2. Turtles were spotted however unable to identify species.

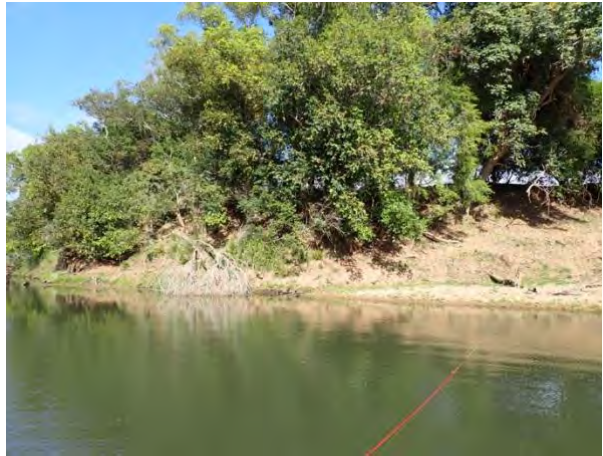
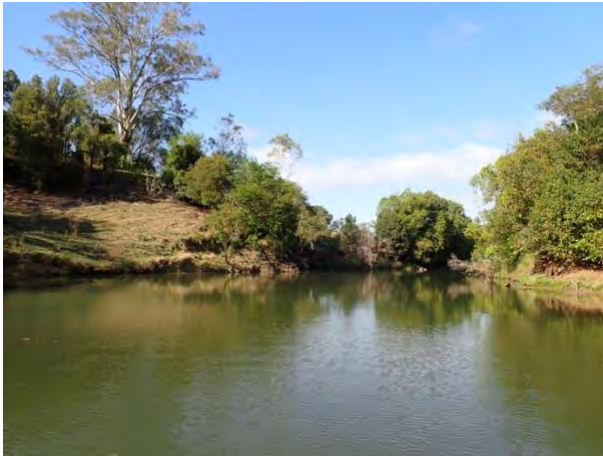
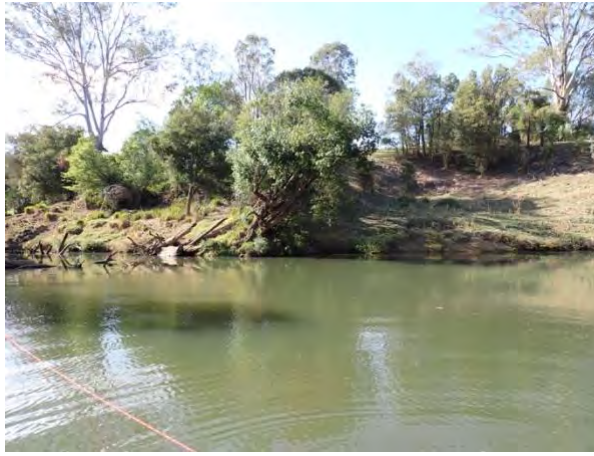
Site MR4

Right bank at mid-site		Upstream at mid-site		Left bank at mid-site	
Water Quality		Flow Conditions			
Temperature (°C)	22.2	Flow habitats present	Connected in-channel pool		
Conductivity (µS/cm)	490.91	Water level	Moderate (at watermark)		
Turbidity (NTU)	7.95	Recent high flow	Yes		
Dissolved oxygen (mg/L)	6.98	Flow	Upstream	Mid-site	Downstream
Dissolved oxygen (% sat)	80.16	Depth (m)	1.7	3.8	0.5
pH	7.25	Width (m)	26.0	45.0	38.0
		Velocity (m/s)	0.035	0.029	0.046

Land Use			
Left bank:	Grazing	Right bank:	Grazing
Overall disturbance:	High		
Bank Assessment			
Left Bank		Right Bank	
Bank material:	Bedrock,sand, gravel, silt/clay	Bank material:	Sand, gravel, silt/clay
Bank height:	5 m	Bank height:	7 m
Bank slope:	Steep	Bank slope:	Steep
Bank shape:	Convex	Bank shape:	Convex
Vegetation cover:	Moderate	Vegetation cover:	Moderate
Vegetation type:	Grass, shrubs, trees	Vegetation type:	Grass, shrubs, trees
Shading of river:	5%	Shading of river:	15%
Trailing bank vegetation:	5%	Trailing bank vegetation:	5%
Erosion Assessment			
Left Bank		Right Bank	
Erosion:	Moderate	Erosion:	Moderate
Stability:	Moderate	Stability:	Moderate
Disturbances:	Erosion, cattle and cleared vegetation	Disturbances:	Erosion, cattle and cleared vegetation
Bed Assessment			
Substrate material:	Boulder, cobble, pebble, gravel, sand, silt/clay		
Bed stability rating:	Moderate aggradation	Sediment deposits:	Sand and silt

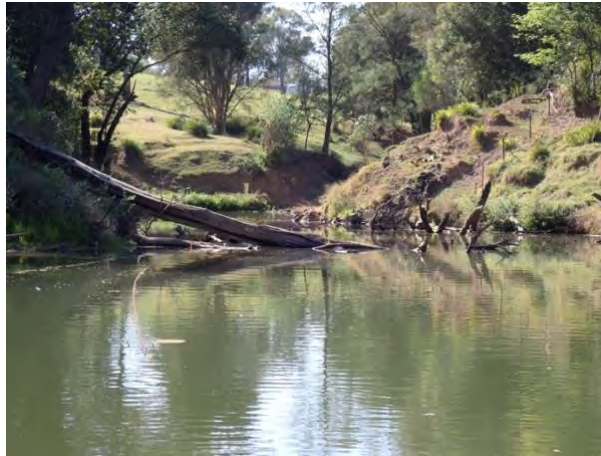
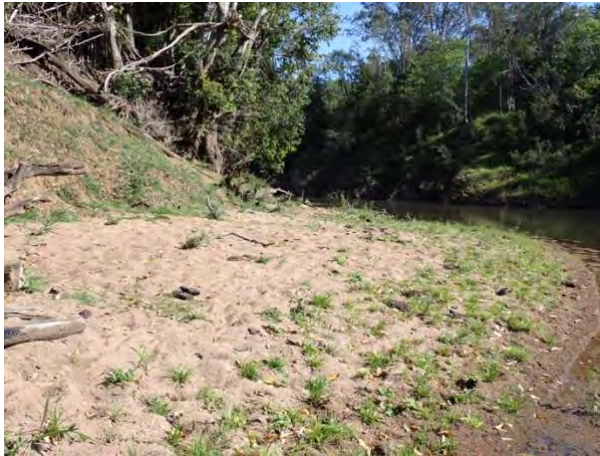
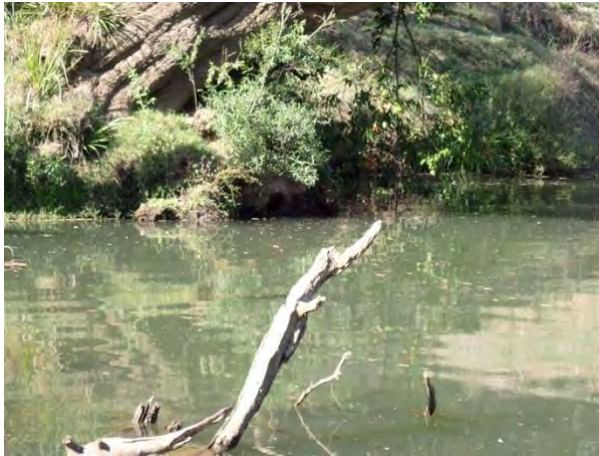
Table B.6 Habitat assessment for MNES species at site MR4.

Logs and woody debris suitable for basking		Sandy bank suitable for nesting	
Undercut banks provide habitat			
Habitat	Present / Absent	Habitat	Present / Absent
Isolated pools	Absent	Individual log (diameter >250mm)	Present
Connected pools	Present	Individual branch (diameter <300mm)	Present
Riffle	Absent	Branch pile <50% dense (diameter <300mm)	Present
Run	Absent	Branch pile >50% dense (diameter <300mm)	Present
Aquatic vegetation	Present	Log jam <50% dense (diameter >300mm)	Present
Turtle basking spots	Present	Log jam >50% dense (diameter >300mm)	Present
Turtle nesting habitat	Present	Terrestrial leaves and twigs	Present – sparse
Submerged boulders / rock crevices	Present		
Overall suitability	Suitable

MNES Species Habitat	
	<p>Suitable habitat for Mary River cod, Australian Lungfish, White-Throated Snapping turtles and Mary River turtles was scattered through the site. Deep pools (>4 m) were present throughout the site during the 2023 survey. Most deep pools contained large woody debris. Turtle basking spots were present in the form of exposed logs and few exposed rocks along banks. Sandy banks suitable for nesting habitat were present. Aquatic vegetation present with sparse aggregations of Azolla sp., Vallisneria sp. and Ludwigia sp. Platypus and unidentified turtles spotted at site.</p>

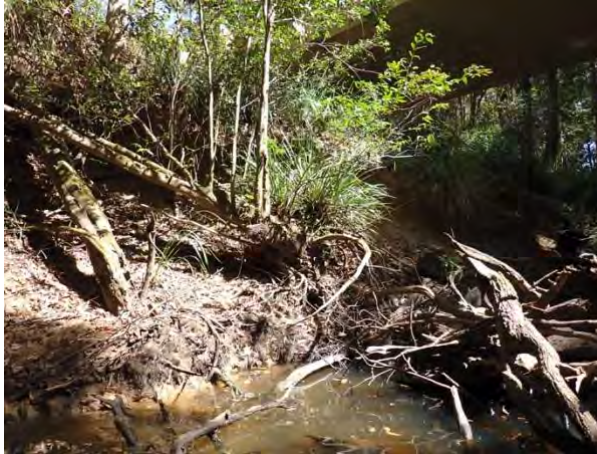
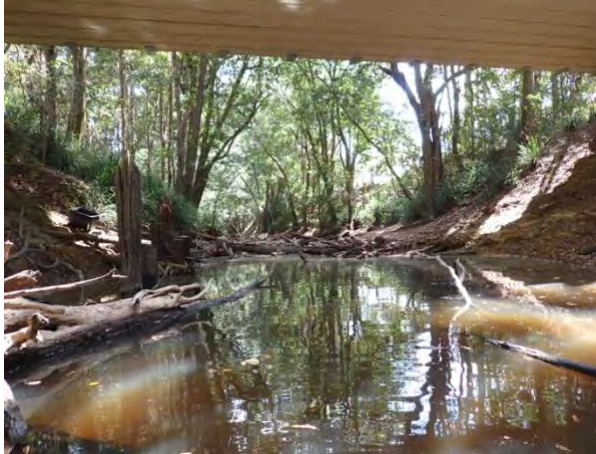
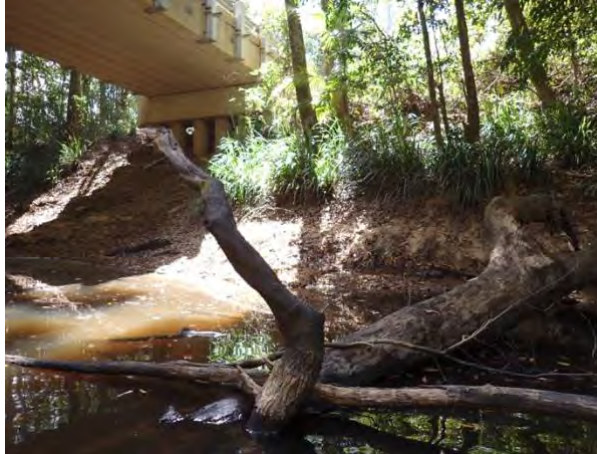
Site SMC4

Right bank at mid-site		Upstream at mid-site		Left bank at mid-site	
Water Quality		Flow Conditions			
Temperature (°C)	18.57	Flow habitats present	Connected in-channel pool, riffle, run		
Conductivity (µS/cm)	239.64	Water level	Low (below watermark)		
Turbidity (NTU)	6.48	Recent high flow	Yes		
Dissolved oxygen (mg/L)	1.85	Flow	Upstream	Mid-site	Downstream
Dissolved oxygen (% sat)	19.77	Depth (m)	0.6	0.9	0.5
pH	6.73	Width (m)	6.5	8.0	8.5
		Velocity (m/s)	0.002	0.011	0.002
Land Use

Left bank:	Grazing	Right bank:	Grazing
Overall disturbance:	High		
Bank Assessment			
Left Bank		Right Bank	
Bank material:	Boulder, sand and silt/clay	Bank material:	Sand and silt/clay
Bank height:	3 m	Bank height:	3 m
Bank slope:	Steep	Bank slope:	Moderate - steep
Bank shape:	Concave	Bank shape:	Convex
Vegetation cover:	Extensive	Vegetation cover:	Extensive
Vegetation type:	Grass, shrubs (<i>Lomandra</i> sp.), trees	Vegetation type:	Grass, shrubs (<i>Lomandra</i> sp.), trees
Shading of river:	75%	Shading of river:	75%
Trailing bank vegetation:	10%	Trailing bank vegetation:	5%
Erosion Assessment			
Left Bank		Right Bank	
Erosion:	Some	Erosion:	Moderate
Stability:	Moderate	Stability:	High
Disturbances:	Roads (bridge), erosion	Disturbances:	Roads (bridge), erosion
Bed Assessment			
Substrate material:	Pebble, gravel, sand, silt/clay		
Bed stability rating:	Moderate aggradation	Sediment deposits:	Sand and silt

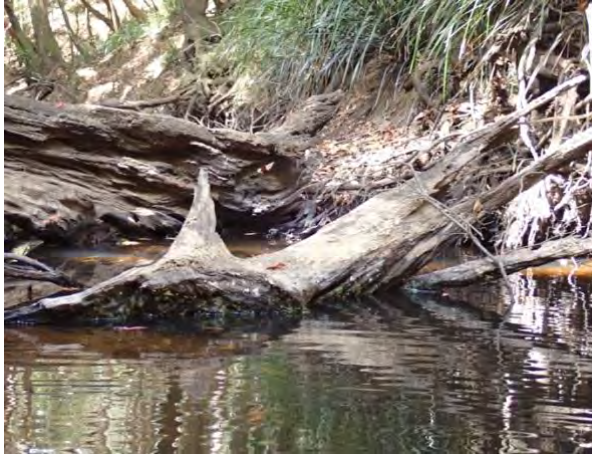
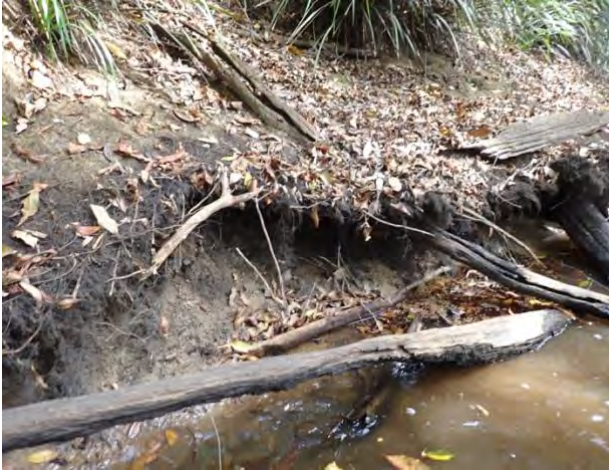
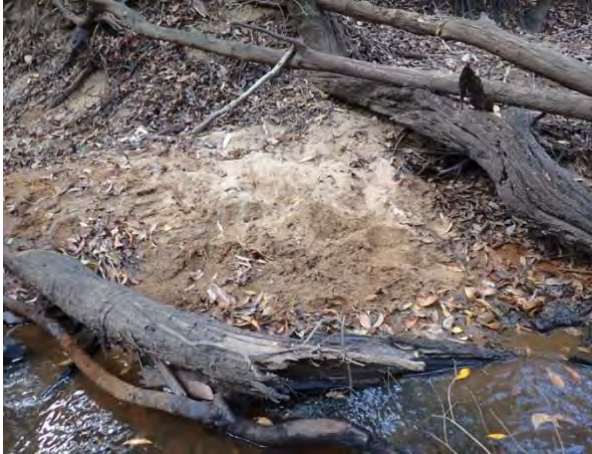
Table B.9 Site SMC4 – habitat assessment for MNES species.

Woody debris provides basking spot		Undercut banks provide habitat	
Sandy bank provides nesting habitat			
Habitat	Present / Absent	Habitat	Present / Absent
Isolated pools	Absent	Individual log (diameter >250mm)	Present
Connected pools	Present	Individual branch (diameter <300mm)	Present
Riffle	Present	Branch pile <50% dense (diameter <300mm)	Present
Run	Present	Branch pile >50% dense (diameter <300mm)	Present
Aquatic vegetation	Present	Log jam <50% dense (diameter >300mm)	Present
Turtle basking spots	Present	Log jam >50% dense (diameter >300mm)	Present
Turtle nesting habitat	Present	Terrestrial leaves and twigs	Present – dense
Submerged boulders / rock crevices	Present

MNES Species Habitat	
Overall suitability	Suitable for White-Throated Snapping turtles and Mary River turtles, potentially suitable for juvenile Mary River cod, not suitable for Australian Lungfish.
Comments:	Extensively shaded, shallow pools (<1 m) throughout the majority of the reach. Submerged woody debris was present across the site, providing potential habitat for juvenile Mary River cod although water level indicates habitat as unsuitable. No suitable habitat for the Australian Lungfish was present. The presence of flowing water in shallow riffles and a sandy substrate provide habitat that is suitable for White-Throated Snapping turtles and Mary River turtles, in addition to sandy nesting habitat on the banks. Woody debris and exposed rocks provided turtle basking spots. Aquatic vegetation present, sparse <i>Azolla sp.</i> aggregations.

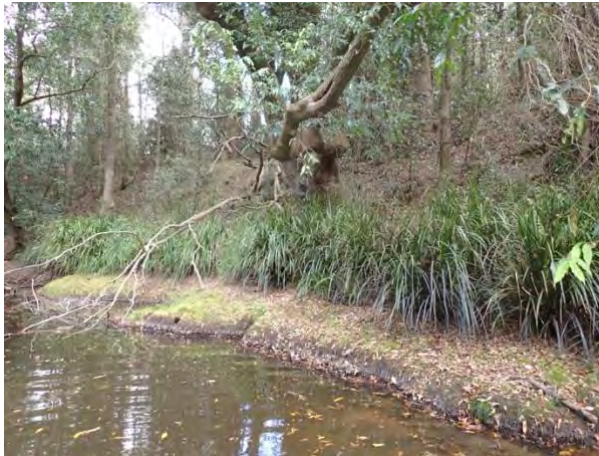
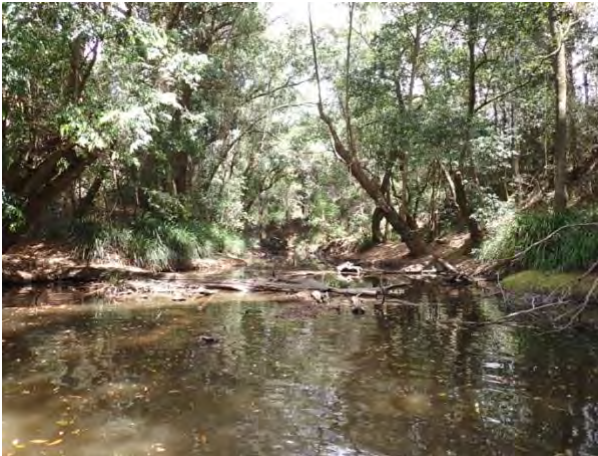
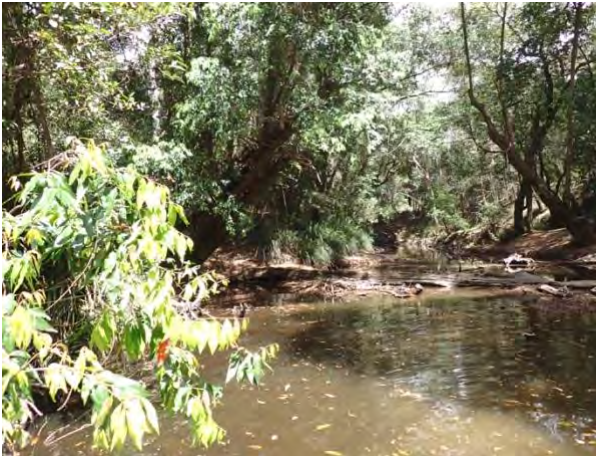
Site SMC5

Right bank at mid-site		Upstream at mid-site		Left bank at mid-site	
Water Quality		Flow Conditions			
Temperature (°C)	20.53	Flow habitats present	Connected in-channel pool		
Conductivity (µS/cm)	270.5	Water level	Low (below watermark)		
Turbidity (NTU)	11.9	Recent high flow	Yes		
Dissolved oxygen (mg/L)	2.28	Flow	Upstream	Mid-site	Downstream
Dissolved oxygen (% sat)	25.41	Depth (m)	0.4	0.3	0.1
pH	6.67	Width (m)	6.5	7.5	7.5
		Velocity (m/s)	0.05	0.05	0.08

Land Use			
Left bank:	Grazing	Right bank:	Grazing
Overall disturbance:	Moderate		
Bank Assessment			
Left Bank		Right Bank	
Bank material:	Boulder, gravel, sand and silt/clay	Bank material:	Gravel, sand, silt/clay
Bank height:	6 m	Bank height:	6 m
Bank slope:	Moderate	Bank slope:	Moderate
Bank shape:	Stepped	Bank shape:	Stepped
Vegetation cover:	Extensive	Vegetation cover:	Extensive
Vegetation type:	Trees, shrubs (<i>Lomandra</i> sp.), grass	Vegetation type:	Trees, shrubs (<i>Lomandra</i> sp.), grass
Shading of river:	50%	Shading of river:	25%
Trailing bank vegetation:	25%	Trailing bank vegetation:	15%
Erosion Assessment			
Left Bank		Right Bank	
Erosion:	Some	Erosion:	Some
Stability:	High	Stability:	Moderate
Disturbances:	Erosion, road (bridge)	Disturbances:	Erosion, road (bridge)
Bed Assessment			
Substrate material:	Boulder, cobble, pebble, gravel, sand, silt/clay		
Bed stability rating:	Bed stable	Sediment deposits:	Silt

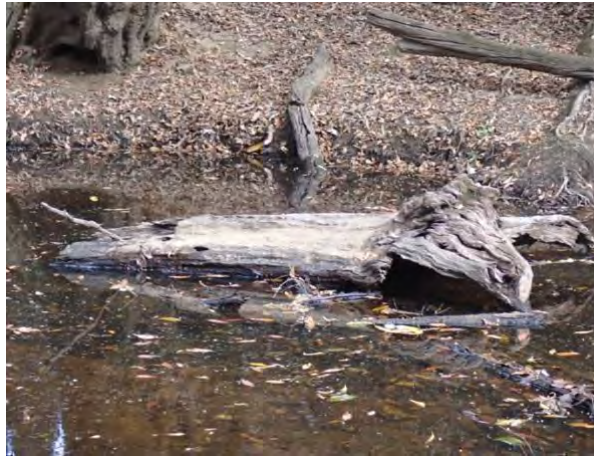
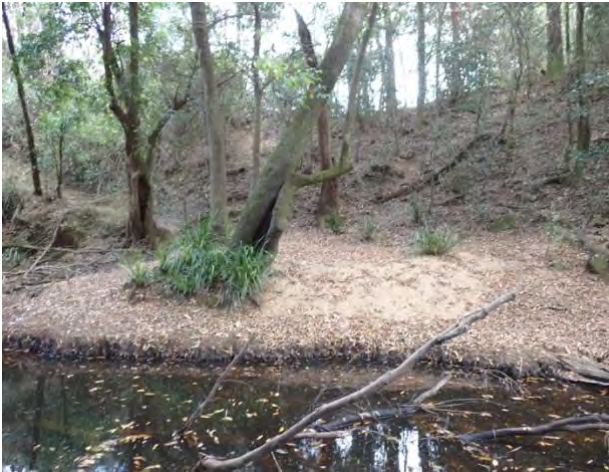
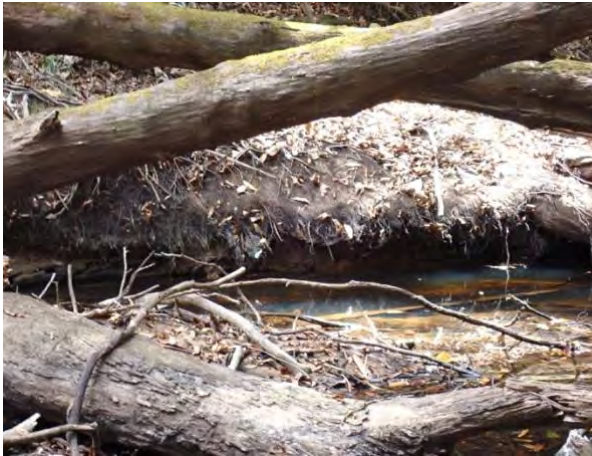
Table B.12 Site SMC5 – habitat assessment for MNES species.

Logs provide basking habitat		Sandy banks provide nesting habitat	
Habitat	Present / Absent	Habitat	Present / Absent
Isolated pools	Absent	Individual log (diameter >250mm)	Present
Connected pools	Present	Individual branch (diameter <300mm)	Present
Riffle	Absent	Branch pile <50% dense (diameter <300mm)	Present
Run	Absent	Branch pile >50% dense (diameter <300mm)	Present
Aquatic vegetation	Absent	Log jam <50% dense (diameter >300mm)	Present
Turtle basking spots	Present	Log jam >50% dense (diameter >300mm)	Present
Turtle nesting habitat	Present	Terrestrial leaves and twigs	Present – dense
Submerged boulders / rock crevices	Present

MNES Species Habitat	
Overall suitability	Potential for White-Throated Snapping turtle and Mary River turtle, potential suitable for juvenile Mary River cod and not suitable for Australian Lungfish.
Comments:	Shallow (<1 m) pools with submerged woody debris and rock faces and crevices were present that may provide some suitable habitat for juvenile Mary River cod, White-Throated Snapping turtle and Mary River turtle. Australian Lungfish habitat was not present. Some suitable foraging habitat for White-Throated Snapping turtles or Mary River turtles in flowing riffles but no deep foraging pools were present. However, protruding logs, woody debris and exposed rocks were present providing suitable basking spots for turtles.
