Seqwater Dam Improvement Program e-update

Leslie Harrison Dam upgrade

Construction update

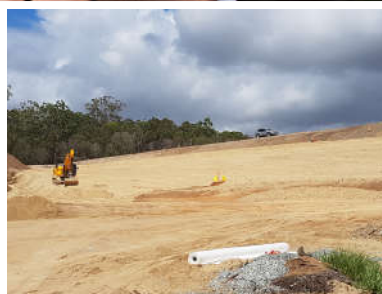
the beach! This is the Leslie Harrison Dam wall with new sand filter layers being installed.

Not

- Putting the final touches to the new conduit (tunnel) that carries the raw water pipeline from the dam to the water treatment plant.
- Finishing the new access shaft that will allow maintenance workers to access the conduit.
- Finishing the weighting berm downstream of the dam wall with earth fill.
- Widening the dam wall with new sand filters and earth fill. This will improve the strength and stability of the dam wall.

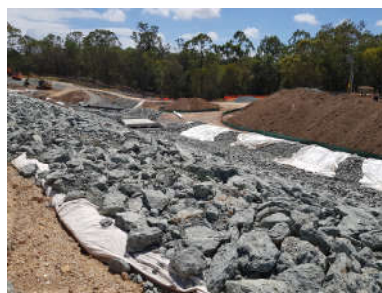
rock lined drains are being installed. During heavy rain events, these drains will move water away from the dam wall.

Huge

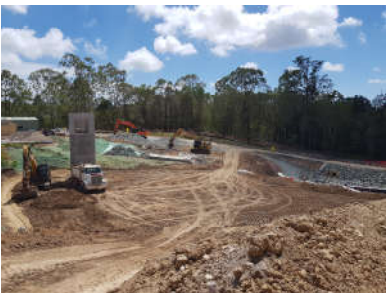
The

conduit has been buried under earth fill. The new raw water pipeline can be seen emerging from the conduit on the right (black pipe). When complete the earth will reach the doorway near the top of the new access shaft.
