Lake Macdonald Dam Information sheet for residents downstream

June 2018

Lake Macdonald Dam information sheet

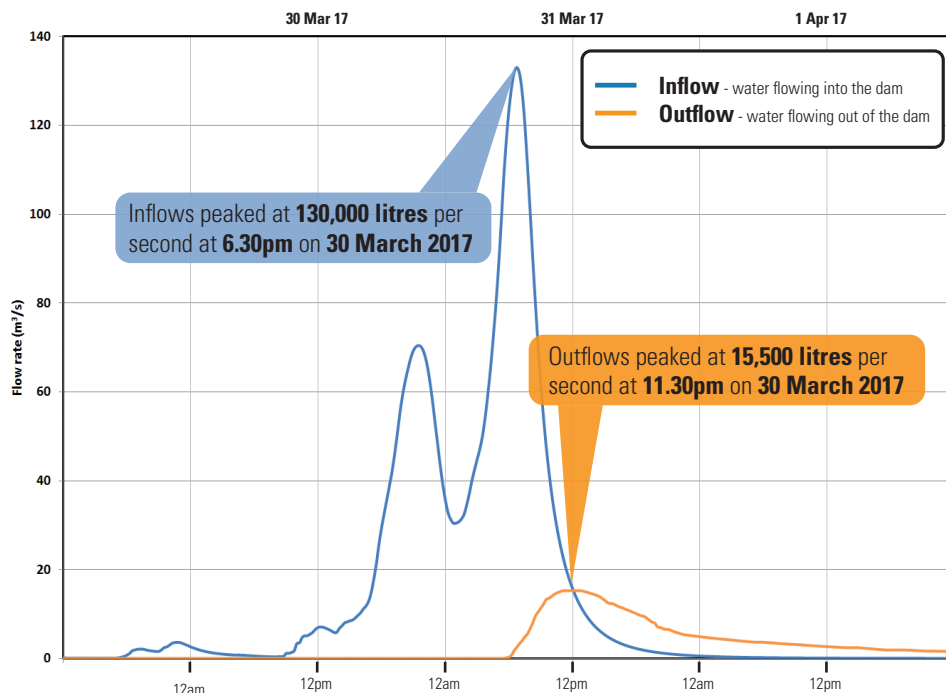
The flow hydrograph for Lake Macdonald Dam associated with ex-Tropical Cyclone Debbie is shown above. Inflows into the dam began at 6.30am on Wednesday 29 March 2017 and the dam began to spill at 7.30pm the following day. The peak inflow occurred at 7pm on Thursday 30 March 2017. The peak outflow occurred later that evening at 11.30pm, coinciding with the lake levels at Lake Macdonald Dam reaching a maximum of 95.77 metres above sea level, which is 0.45 metres above its full supply level.

- Ex-TC Debbie produced the largest flows in Six Mile Creek since 2013.
- During the event, inflow into Lake Macdonald Dam peaked at around 120 cubic metres per second (or 130,000 litres per second) at 6.30pm on 30 March 2017 – the equivalent rate would fill an Olympic-sized swimming pool in 17 minutes.
- The water level at Lake Macdonald Dam peaked at 95.77 metres above sea level – about 0.45 metres above the spillway crest.
- This peak level was still 1.6 metres below the flood of record for Lake Macdonald, which occurred in February 2012.
- The peak outflow through the un-gated spillway at Lake Macdonald Dam during ex-TC Debbie was about 15.5 cubic metres per second (or 15,500 litres per second).
